FIELD INSPECTION

Project Name:	Mountain Valley Pipeline	Inspector:	Matthew Grant
Inspection Date:	Tuesday, April 2, 2019	Project Contact:	Brian Clauto
Spread: Pittsylvania County MP294-295 St15529-15584	Spread I	Weather (Wet/Dry/Rain):	Dry

FIELD INSPECTION PHOTO LOG

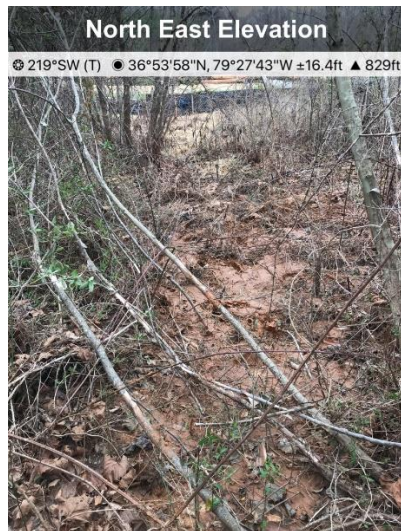
- Fig. 1 St#15543+20 sediment off of ROW

Recommended Corrective Action: Maintain all controls per the approved plan and specs, remove sediment per DEQ approval.

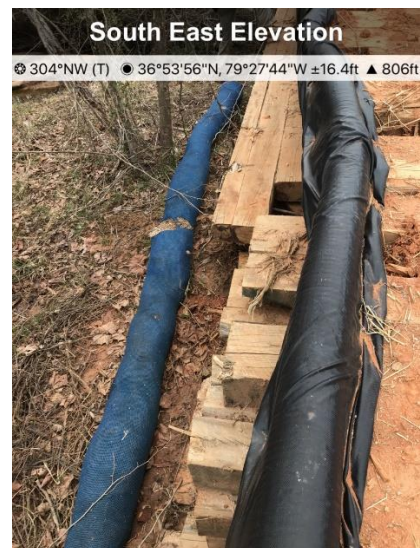
- Fig. 2 St#15543+00 at SCC5 buffer area CFS has a hole in the side of it
